Destructive Physical Analysis of Hollow Cathodes from the Deep Space 1 Flight Spare Ion Engine 30,000 Hr Life Test

IEPC-2005-026

Presented at the 29th International Electric Propulsion Conference, Princeton University,
October 31 – November 4, 2005

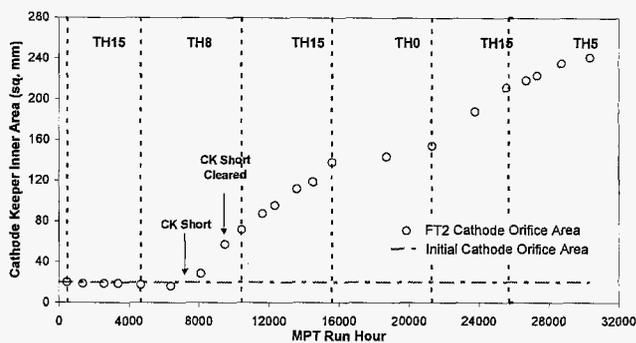
Figure 2 is a plot of normalized cathode-keeper-orifice diameter versus runtime, and clearly indicates the onset and subsequent power-level-dependence of keeper erosion. It is important to note that this severe keeper erosion was not observed during the first full-power test segment, from 500 to 4500 hrs, or during the previous 8,000-hr endurance test of the EMT^{4,5}, which was operated exclusively at TH15. This suggests that the TH8 operating conditions, the shorted condition, or both initiated the cathode-keeper erosion observed during FT2 testing.

Figure 2. Cathode keeper plate erosion versus runtime.

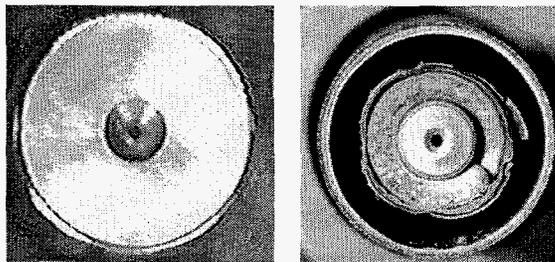
Figure 3 is a photographic comparison of the BOL condition and the EOT condition of the cathode-keeper assembly. All images except the one at 30,352 hrs were taken with the internal tank video system, focused through the optics assembly. Keeper-surface pitting was initially apparent after 5000 hrs of operation. By 10,000 hrs, the keeper plate had eroded significantly, partially exposing the cathode-orifice plate. By 15,000 hrs the keeper-orifice plate had eroded to fully expose the cathode-orifice plate and heater. The image labeled 30,352 hrs was taken after the thruster was removed from the chamber, with the grids removed. This most recent image indicates that the cathode heater and orifice plate had eroded as a result of their exposure to the discharge-chamber plasma for the last 15,000 hrs of operation. This observation will be discussed in more detail in the following sections.

Figure 3. Cathode keeper BOL (left) and after 30,352 Hours of operation (right).

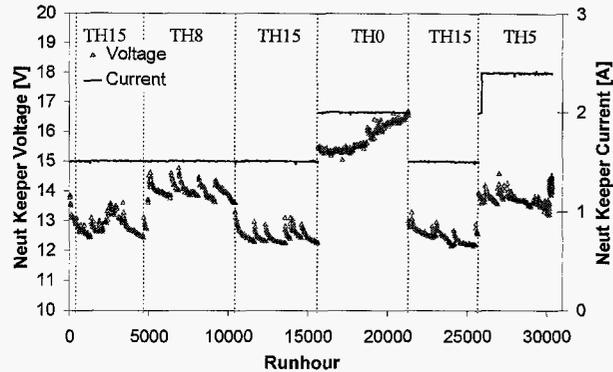
Figure 5 is a plot of the neutralizer-keeper DC voltage and current versus runtime. The spikes in voltage observed repeatedly over the course of the test correspond to cathode-conditioning events. Cathode conditioning is a process whereby cathode-heater current is applied at various levels to burn off surface contaminants that may have deposited/adsorbed on the cathode surfaces due to exposure to a higher than nominal tank pressure. Higher tank pressure was defined as facility pressure in excess of 1.33×10^{-3} Pa (1×10^{-5} Torr) during a cryopump regeneration or pressure spike. The spikes in the keeper voltage following each conditioning were due to changes to the insert chemistry as a result of the applied heater current.

Figure 5 also indicates that neutralizer-keeper performance characteristics were relatively stable during the first three test segments. The neutralizer performance first began to show signs of degradation during the fourth test segment, corresponding to operation at TH0 (0.5 kW). The DC and AC characteristics began to increase 800 hrs into TH0 operation, and deposits began to form within the orifice, as documented by the in situ camera system. By the conclusion of the 5700-hr TH0 segment, internal tank video inspections revealed that the orifice was over 50% blocked (Figure 5.2-3), and the flow-rate margin from plume mode had dropped to below acceptable levels at the nominal flow-rate setpoint. It is theorized that the deposits in the orifice are responsible for the degradation in neutralizer performance, further supported by the results of the subsequent TH15 operation. The thruster was returned to full-power operation following the TH0 test segment, and remained at the TH15 power point for approximately 5000 hrs. During this test segment, the deposits within the orifice were removed, and the TH0 keeper-voltage characteristics and flow-rate margin from plume mode returned to nominal levels. This suggests that operation at the higher power level removed the deposits, and that the deposition mechanism is likely power-level-dependent, specifically manifesting itself during low-power operation. This suggests a temperature-dependence to the orifice-clogging mechanism, with hotter operation eliminating orifice deposits.

Figure 5. Neutralizer keeper voltage and current versus runtime.

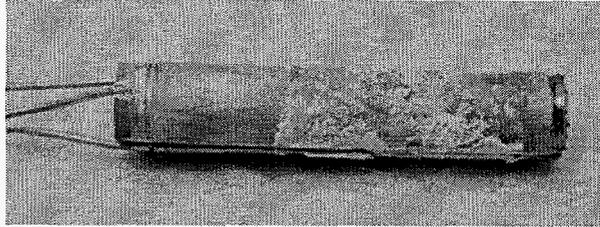
The post-test condition of the insert was documented after removal from the cathode tube. The post-test condition of the exterior and interior can be seen in Figure 6. The white crust on the exterior surface is barium oxide (BaO) migrated from the tungsten matrix. The BaO layer was present at all but the upstream end of the insert, where the temperature is expected to be lowest. The post-test condition of the insert interior can be seen in greater detail in Figure 7. Heavy crystal deposition was apparent at the downstream end, with significantly less in the upstream direction. This observation will be discussed in more detail in the following sections.

Figure 6. The exterior surface of the discharge cathode insert after 30,352 hours of operation.

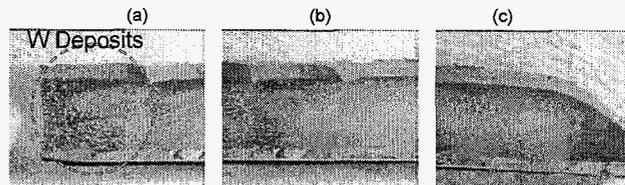
The fractured insert geometry allows analysis of chemical composition at the ID surface and as a function of depth from the ID surface. SEM and EDX analyses were used to probe the fracture surface of both the 30,000-hr ELT insert and an unused 4:1:1 insert, to provide a comparative estimate of impregnate depletion and surface-chemistry changes. SEM inspection of the insert revealed heavy tungsten crystallite deposition at the extreme downstream end, nearest the orifice plate. Figure 8 shows the tungsten crystals and a relative coverage area of 30–40% of the tungsten matrix below, at the downstream end. It should also be noted that apart from the tungsten crystallites, tungstates and other oxide/poisoning layers were not detected on the entirety of the surface. This is a critical finding, for oxide layers and tungstate formation are typically responsible for limiting cathode life by preventing BaO migration to the surface and consequently reducing the reaction that allows for thermionic emission. SEM inspection of the insert surface midway along its length revealed no tungsten crystallite formation and no oxide layers (Figure 9). SEM inspection at the upstream end of the ID surface revealed molybdenum oxide (MoO) deposits in the vicinity of the Mo collar (Figure 10). Crystallite formation was also not present at the upstream end.

Figure 7. Insert ID surface from (a) downstream, (b) middle, and (c) upstream.

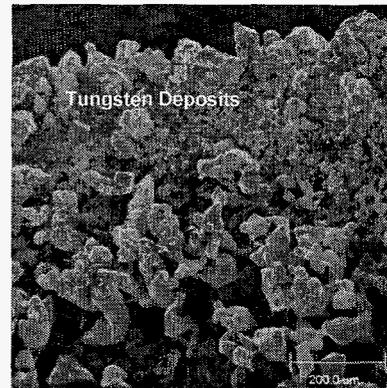
Figure 8. Insert ID at the downstream end showing tungsten crystallites.

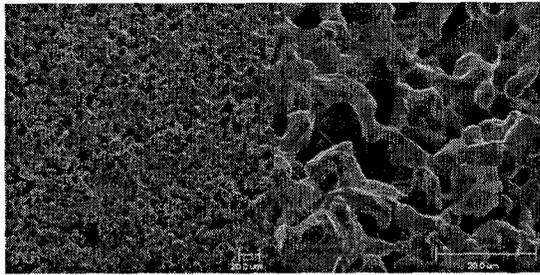
Figure 9. Insert ID surface at middle showing absence of crystallite formation at different magnifications.

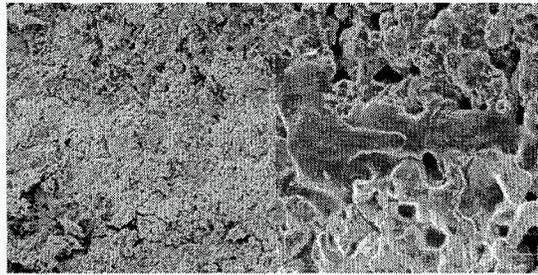
Figure 10. Insert ID surface at downstream end showing MoO deposits at different magnifications.

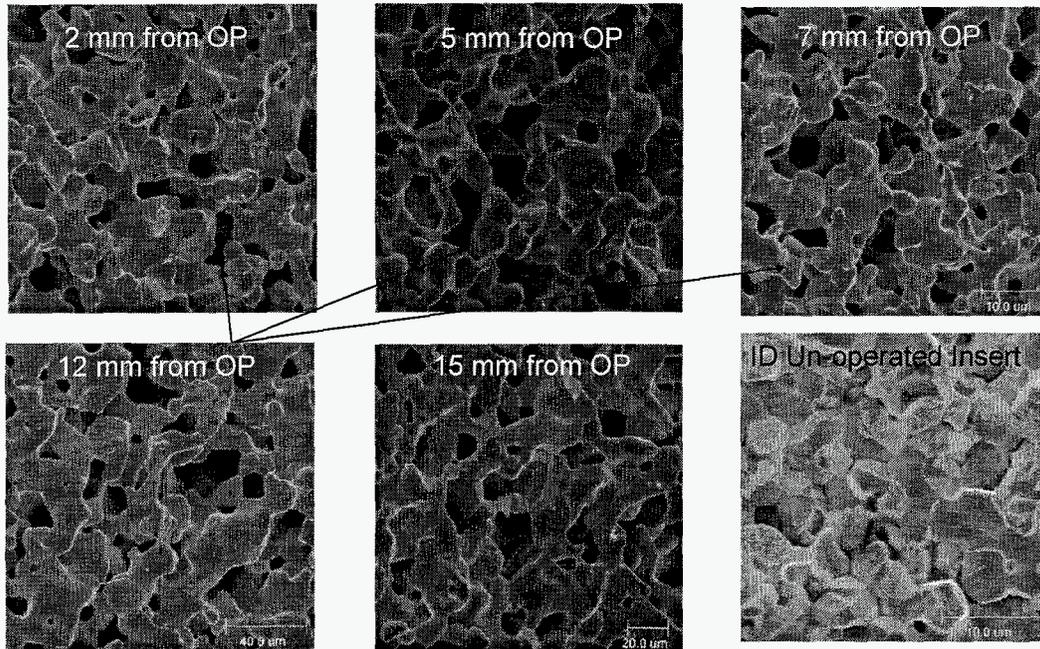
Figure 11 shows the ID surface of the unused insert to the ID surface of the ELT insert at several axial locations. The white substance present in the tungsten matrix of the unoperated ID surface is the impregnate material. The impregnate is not present at the ID of the ELT insert: it has been depleted due to operation. As will be discussed in the next section, although depleted at the surface, the impregnate material is present in the subsurface of the matrix of the ELT insert, available for evaporation to the surface during cathode operation.

Figure 11. Axial variation of ID surface for ELT insert given as distance from orifice plate (OP) compared to the nominal ID surface of the control insert.

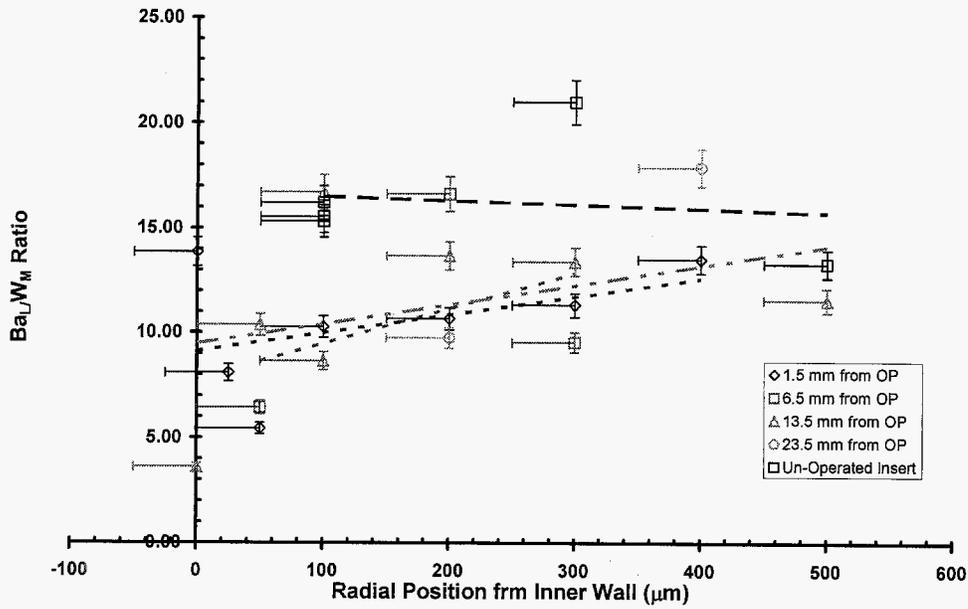
EDX analysis was used to measure impregnate depletion. This was accomplished by measuring the relative signal strengths for Barium and tungsten at several different locations for each insert. Ba:W ratio measurements for the control insert at different depths from the ID surface were used as the baseline for the absence of impregnate depletion at a given depth and were compared to the ELT insert. Figure 12 compares the Ba:W ratio versus depth from the ID surface. Using the metric described above, the impregnate material depletion depth was calculated as a function of axial distance from the orifice plate (downstream end) and is shown in Figure 13.

Figure 12. Ba:W ratio variation from the ID surface for the ELT and control insert

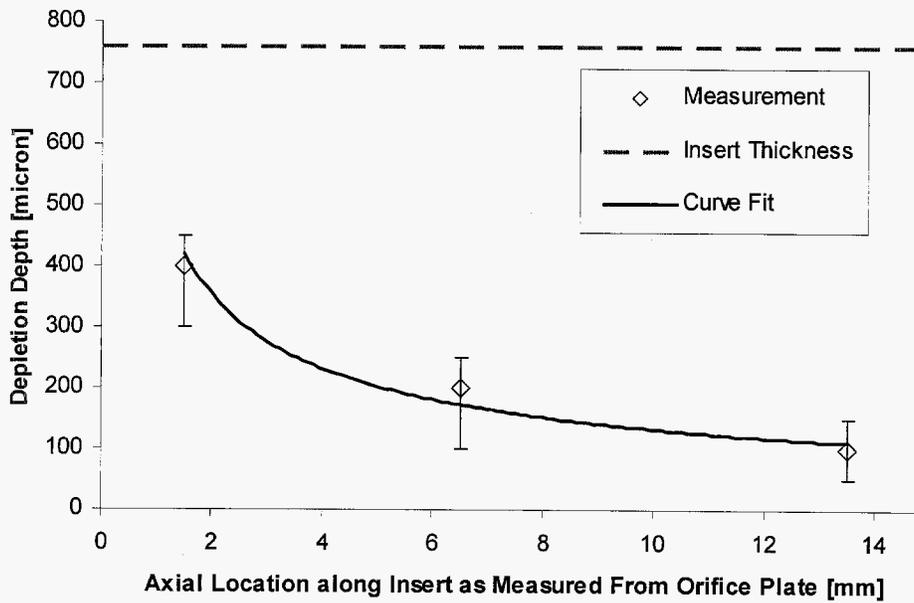
Figure 13. Ba:W ratio variation from the ID surface for the ELT and control insert

The insert was more heavily depleted at the downstream end, exhibiting a nonlinear decrease with axial distance from the orifice plate. At the downstream end, the insert was depleted to $400 (\pm 50) \mu\text{m}$, which is equivalent to 52% of the total insert thickness. At 13.5 mm upstream from the orifice plate, the insert was depleted by only 13%. Figure 14 is a comparison of the subsurface insert fracture surface for the ELT and control insert. Impregnate material (white substance) can be seen in the subsurface material, corresponding to the Ba:W measurements. Although partially depleted, the ELT cathode insert operated nominally through to the conclusion of the test,

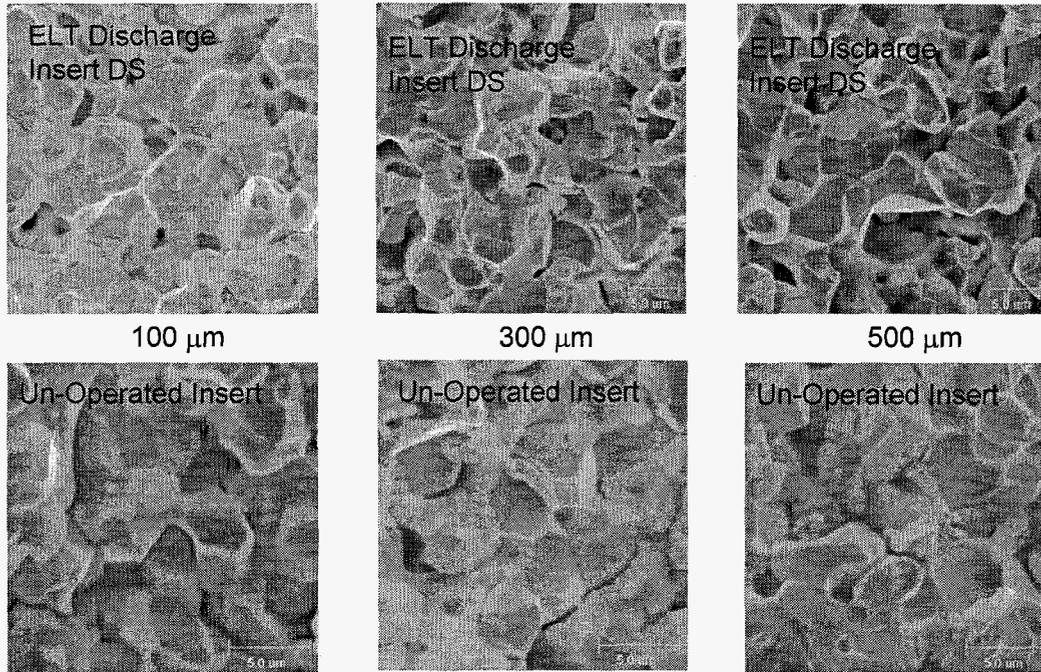
Figure 14. Comparison of ELT and control insert downstream fracture surface as a function of depth from the ID surface

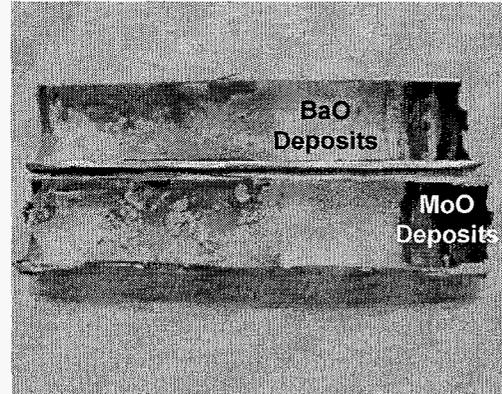
Post-test examination of the discharge-cathode-keeper tube is shown in Figure 15. The image shows the post-test condition of the cathode tube interior. Examination of the discharge-cathode tube revealed a significant quantity of BaO on the ID surface. The origin of the BaO is the insert itself, which had fused to the interior surface of the cathode tube. The trend noted was increasing BaO deposition in the downstream direction, which corresponds to the higher temperature. MoO deposits were found at the upstream end of the tube, likely from the Mo collar that is located concentric to this region. There was no measurable erosion to the cathode tube, only net deposition on the interior.

Figure 15. Post test condition of the cathode tube interior showing BaO and MoO deposits.

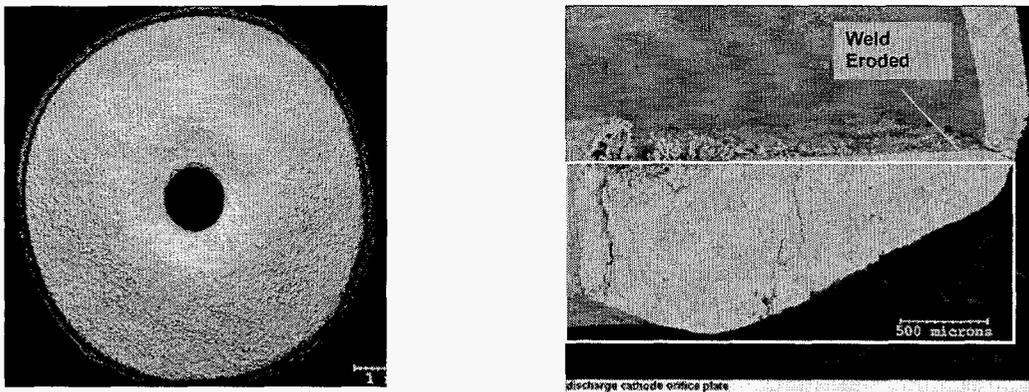
Post-test examination of the cathode-orifice plate revealed that surface erosion of the orifice plate was more severe than was previously surmised from the in situ photography taken during the test. The cathode-orifice-plate-to-cathode-tube electronic-beam weld joint was fully removed by ion-bombardment sputter-erosion of the plate surface after 30,000 hrs of operation. The weld was initially located on the side of the plate, at the midway point through the thickness dimension. By the conclusion of the test, the periphery of the plate was only 28% of the BOL plate thickness (Figure. 16). Although the weld joint was fully removed by sputter-erosion, the orifice plate was still adhering to the cathode-tube wall and ledge at the conclusion of the test. SEM analysis indicates that this adherence was due to a 20-to-50- μm -wide area of fusion between the molybdenum-rhenium (MoRe) cathode tube and tungsten orifice plate. If not for this small area of thermally induced fusion, the plate may have fallen off, resulting in cathode

Figure 16. Post test condition of the cathode orifice plate showing the (left) downstream side and (right) cross sectional view of orifice and tube connection. The box indicates the pre-test geometry of the plate.

failure. This is a key finding of the ELT, in that minimizing cathode-keeper erosion to prevent ion-bombardment of the orifice plate is essential to prevent premature cathode failure. Laser profilometer scans across the surface provided revealed that approximately 128 mg of the tungsten plate had eroded after 30,000 hrs of operation.

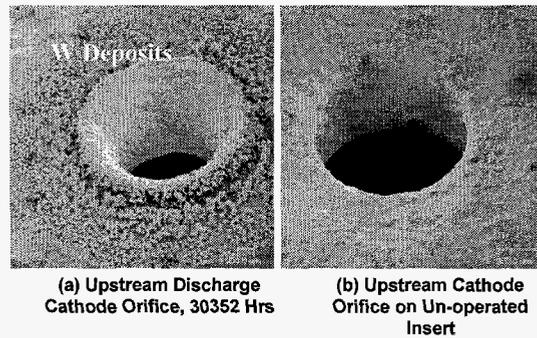
Examination of the upstream surface of the cathode-orifice plate revealed heavy deposition of tungsten on the plate surface and inside the orifice channel. Figure 17 compares the post-test condition of the upstream ELT orifice with the upstream orifice of an unoperated cathode-orifice-plate. The tungsten crystallite density was highest in the vicinity of the orifice, forming a smooth region that extended from the orifice radially from the center. From 0.37 mm to 0.717 mm radially from the orifice, the deposit consisted of individual, large tungsten crystals. Beyond this, smaller particle deposits of both tungsten and Barium were scattered from 0.717 mm to several mm out radially. Dense tungsten deposition also occurred within the orifice, reaching a maximum thickness of 50 μm on the channel wall. The composition of the orifice deposit is predominantly tungsten, with an increasing Mo content towards the ID of the deposit.

Figure 17. Comparison of upstream (a) ELT and (b) un-operated cathode orifice plate.

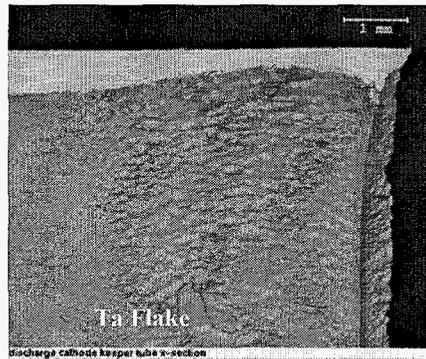
Post-test examination of the discharge-cathode-keeper assembly confirmed the complete removal of the keeper plate due to sputter-erosion during the test. Examination of the keeper tube revealed significant erosion of the inner-wall thickness at downstream end (Figure 18). The maximum erosion occurred 2.5 mm from the downstream end, where up to 47% of the wall thickness was removed. In addition to the net erosion, deposits of varying morphology were also found adhered to the interior of the cathode tube. The deposits were primarily Ta but had increasing Mo content and striated appearance in the upstream direction. In addition to these deposits, a few large Ta pieces were also found fused to the interior of the downstream tube wall. The source of the large Ta deposits is likely flaking of the discharge-cathode-heater radiation shield, which occurred after there was sufficient erosion of the cathode-keeper plate to expose the radiation shield to the main discharge plasma. The large Ta flakes were a few mm long, large enough to cause a grid-to-grid short and/or severe ion-impingement of the accelerator grid. The flaking of the radiation shield, a direct result of keeper erosion, represents a previously underappreciated mechanism that could potentially lead to an unclearable grid-to-grid short or rogue holes.

Figure 18. Erosion of the interior downstream end of the keeper tube.

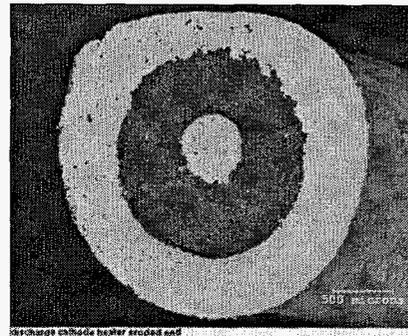
Post-test examination of the cathode heater revealed significant sputter-erosion and Ta crystallite growth on the surface of the downstream coil. The source of the crystallites is sputter eroded heater-sheath Ta that re-deposited on the heater sheath. Only the last coil exhibited erosion, for it was exposed to discharge-plasma ion-bombardment following removal of the keeper plate. Figure 19 is a cross section of the discharge heater of the eroded downstream (last) coil. The magnesium oxide (MgO) insulating layer and center conductor dimensions and appearance were nominal in the eroded heater cross-section. The outer Ta sheath eroded up to 150 μm from nominal wall thickness as compared to an uneroded cross-section. The sheath also exhibited surface cracking in several locations, but EDX scans confirmed no migration of the MgO insulator through the sheath anywhere in the eroded region .

Figure 19. Cross section of eroded heater coil.

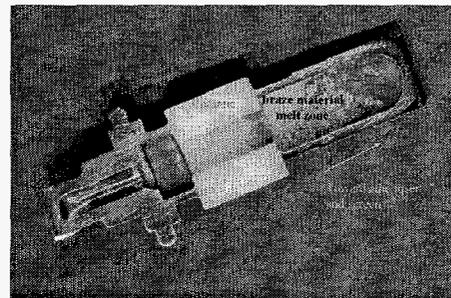
Post-test examination of the low-voltage propellant-isolator assembly also revealed evidence of arcing, suggesting operation outside of its design envelope (Figure 21). Arc tracking and melting were observed on the discharge propellant-line screen, as mentioned previously. Post-test inspection of the ceramic-to-metal braze joints also revealed evidence of high-temperature exposure, with a submicron-thick deposit of nickel (Ni) and copper (Cu) braze material along the entire length of the ceramic, and large deposits of braze material in the right-angle adapter. This is critical, for during the ELT, the impedance between cathode and anode varied dramatically from the GΩ's at BOL to MΩ's at EOT. It is likely that this layer of redeposited Ni and Cu braze was the conductive path from cathode common to anode, which manifested itself during the test as a varying resistance between these two points. It is believed that an electrical discharge through the isolator is responsible for this arc damage. The low-voltage isolator is designed to reliably stand off about 100 V. In normal operation it must stand off the cathode-to-anode potential of approximately 25 V, well within its capability. However, during an engine restart procedure, 250 V was nominally used to ignite the cathode. At the beginning of the test, a more flight-like start circuit was used that applied a 650-V pulse between cathode and anode. For one or more of these reasons, it is likely that operation beyond the design limit of the isolator resulted in arcing across it during the ELT. X-ray examination of the isolator confirms that the ceramic and propellant-line connections were intact at the conclusion of the test. Therefore the use of the low-voltage propellant isolator in the NSTAR thruster represents a potential failure mechanism due to braze-joint failure.

Figure 21. Cross section of the low voltage propellant isolator.

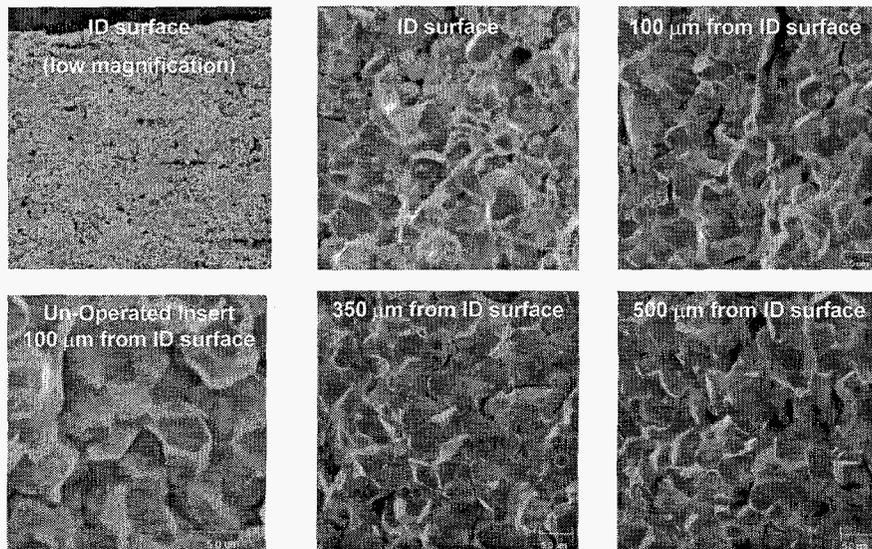
Analysis of the fracture surface of the neutralizer insert was performed by Georgia Institute of Technology. Unlike the discharge cathode insert, the outer diameter (OD) surface of the neutralizer-cathode insert was clean, with no BaO deposition (Figure 23). The neutralizer insert had significantly less W crystallite deposition than did the discharge cathode insert described previously. Figure 23 is a comparison of the insert fracture surface at 100, 350, and 500 μm from the ID surface. The unoperated insert at 100 μm from the ID surface is shown for comparison. Impregnate material depletion is evident at 100 and 350 μm from the ID surface though this depletion is less than that for the discharge-cathode insert. Figure 25 is a comparison of the Ba:W ratio for the unoperated insert and the neutralizer insert at the downstream end, as a function of depth from the surface. Like the cathode insert, the neutralizer insert surface was depleted of impregnate material relative to the unoperated insert. Impregnate material found roughly 300 μm from the surface of the neutralizer insert was equivalent to that found in the unoperated insert at the same depth, and the neutralizer insert had a greater signal strength than the unoperated insert. This is equivalent to 40% depletion from the ID surface.

Figure 23. Neutralizer insert fracture surface at different depths from the ID surface.

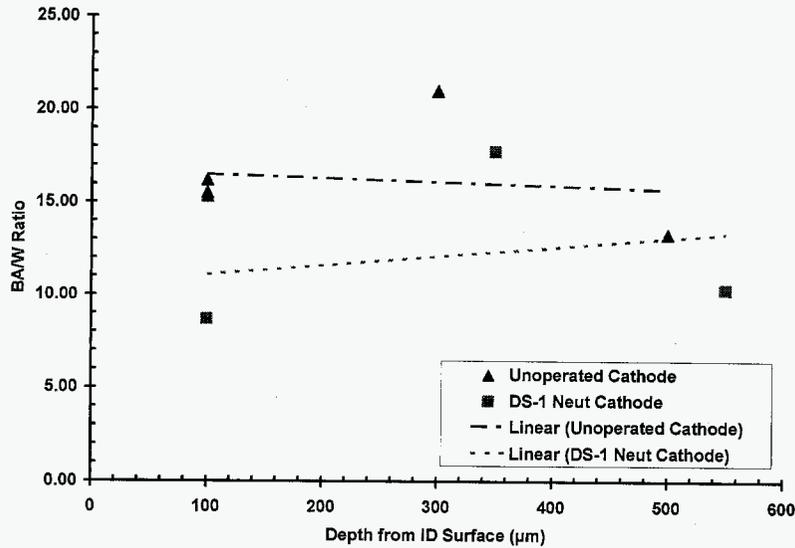
Figure 24. Comparison of Ba:W ratio measurements with depth for the ID surface for the neutralizer and un-operated insert.

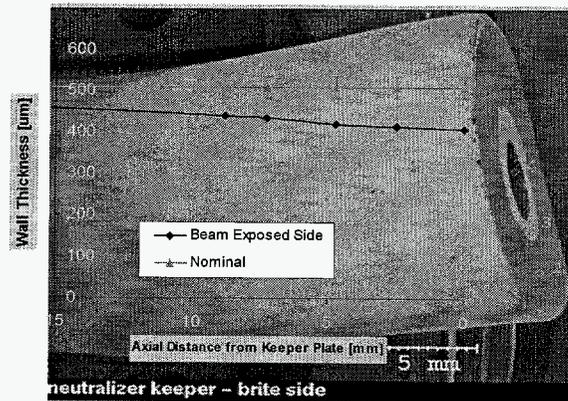
Post-test examination of the neutralizer-keeper tube indicated significant erosion of the wall thickness on the beam-exposed side. Measurements indicate that the beam-exposed tube had eroded up to 20% from the nominal wall thickness at the downstream end (Figure 25)^{1,2}. This erosion is the result of direct ion-impingement and is proportional to the beam voltage, providing a potential failure mode for higher-specific-impulse thruster designs. The non-exposed side of the keeper tube and the downstream face of the keeper plate had a primarily carbon coating up to 16 μm thick, the result of re-deposition of facility material in the thruster plane. The interior of the keeper tube was also examined under the SEM. Submicron-thick layers of Mo, Re, and stainless elements were deposited in bands on the ID surface. The composition varied with increasing stainless content and with proximity to the keeper plate. No net erosion of the keeper-tube interior was measured.

Figure 25. Neutralizer keeper tube post test condition overlaid with erosion profile.

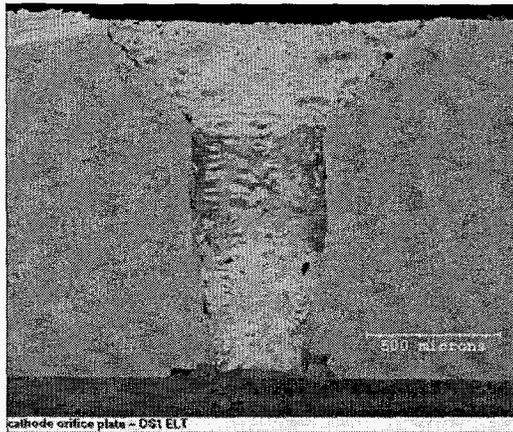
SEM inspection of the neutralizer-orifice plate and channel revealed the absence of erosion in the thickness dimension, no erosion of the plate-to-tube weld, and no evidence of the deposits that clogged the orifice, previously photographed during the TH0 test segment (Figure 26). The orifice channel exhibited net erosion, as seen in Figure 5.2 26a. Comparison of the net erosion of the 30,352-hr ELT with that of the 8,000-hr LDT neutralizer orifice indicates that the profile and magnitude are identical⁵. Therefore, neutralizer-orifice erosion essentially stopped at or before 8,000 hrs of operation. The morphology and geometry of the surface indicate that the chamfer section did not experience any net erosion and its roughened appearance is consistent with a chemically etched surface. The channel section, however has a smooth, crystallite-structure surface, a result of net erosion of the thoriated-tungsten matrix.

Figure 26. Neutralizer keeper tube post test condition overlaid with erosion profile.

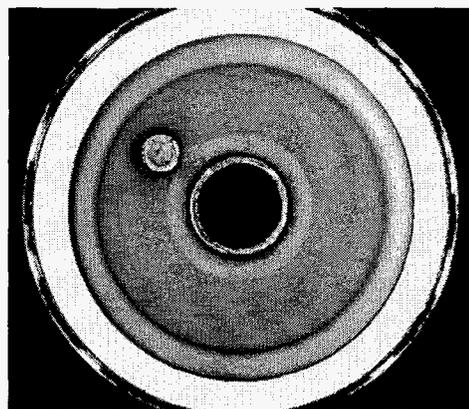
Figure 27. Neutralizer insulator downstream surface showing carbon deposition (brown).

downstream surface of the ceramic, and a conductive path from the central cathode tube to the surrounding keeper tube is visible in Figure 27. Although the coating was too thin to measure its thickness quantitatively with EDX analysis, a resistivity calculation made along the conductive path indicates that a C coating on the order of 25 to 30 Å is sufficient to provide the measured EOT impedance. This finding is critical in that it shows impedance degradation between neutralizer-common and -keeper to be a purely facility-induced effect that would not occur if the engine were operated in the vacuum of space.

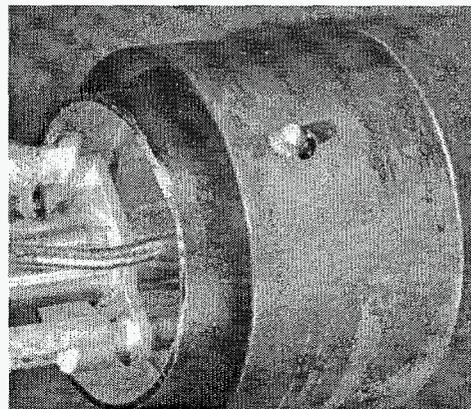
As mentioned previously, neutralizer-keeper-to-ground impedance reduced dramatically during the first 2000 hrs of operation and was in the $k\Omega$ range at the conclusion of the test. Inspection of the electrical path from the ground connection to the keeper electrode also indicated the presence of a C coating providing a path from the keeper to the tank-grounded inner cylinder (Figure 28). In addition to the carbon path from keeper to ground, what appears to be melted braze material in the vicinity of the keeper wire termination was found between the concentric keeper and grounded cylinders. An IR thermal scan was performed to see if this area of re-deposited braze material was providing a conductive path from keeper to ground. The thermal scan indicated that the region of the feed-through where the re-deposited braze material was found appeared hotter than the surrounding area. Therefore, the re-deposited braze, in conjunction with the C deposition on the Mo collar, was responsible for the conductive path across the ceramic and the resultant impedance degradation. It is believed that the braze material found surrounding the feed-through was a result of the nominal manufacturing process. If so, this represents a quality-control issue for future NSTAR neutralizer fabrications.

Figure 28. Carbon deposition (blue) on neutralizer ground potential inner cylinder.
